ADDENDUM #002 RFQ 106-2026

Solicitation: RFQ 106-2026, Professional Architectural Consulting Services for Raa Middle School Project

AUGUSTA RAA MIDDLE SCHOOL

FACILITY 0092 124,254 TOTAL SQUARE FEET 1,121 STUDENT STATIONS

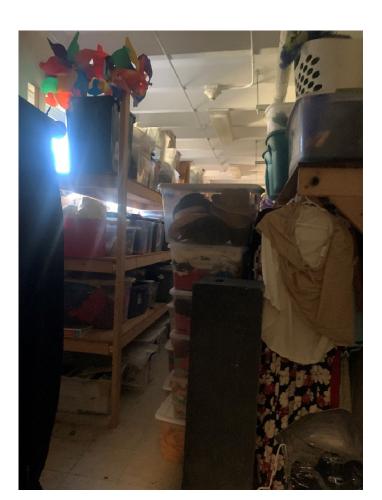
1. The use of Building 09 is to serve as a girl's locker room which does not comply with code. It should be in the multipurpose / gym with the same accommodations and adjacencies as the boy's locker room.

Storage for the stage is housed in this building – remotely from Building 10. It serves no programmatic function to building 09.

The recommendation is full demolition and provide new girls locker room amenities in new gymbuilding.

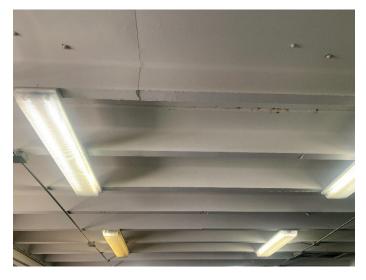
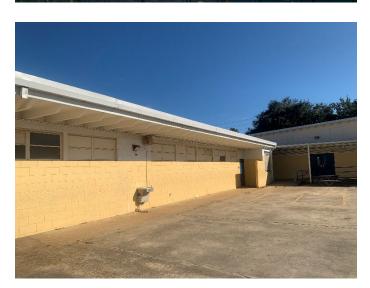
The photo below illustrates the deficiency in storage for Building 10. Building 09 serves as overflow storage for the gym and stage.

The precast double tee spanning the existing ground floor walls becomes costly when having to make any penetrations for plumbing, HVAC, drains, etc. that may be required in the renovation of the space.

Maintaining the double tees in place will require furring down to accommodate light fixtures, HVAC duct and other above ceiling elements. Ceiling heights would be compromised and must be coordinated with window locations.

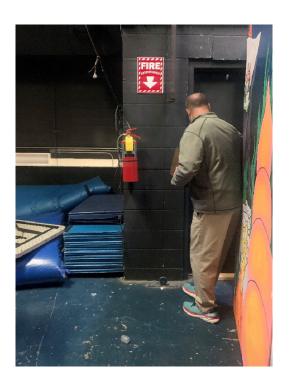
The existing stage has limited space. It currently houses a boiler room on one side and a mechanical room on the other, leaving no space for the required dressing rooms and storage for props and costumes – currently stored remotely in Building 09.

The recommendation is full demolition and replacement of Building 10

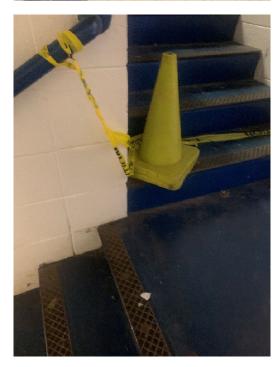
The precast double tee spanning the existing ground floor walls becomes costly when having to make any penetrations for plumbing, HVAC, drains, etc. that may be required in the renovation of the space.

Maintaining the double tees in place will require furring down to accommodate light fixtures, HVAC duct and other above ceiling elements. Ceiling heights would be compromised.

Existing stair design, configurations do not meet code requirements and do not provide an opportunity to install a lift for ADA access.

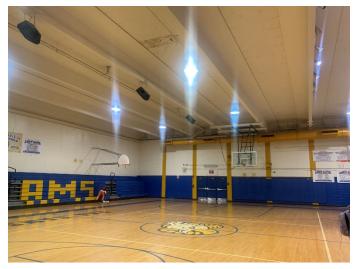
Internal drains leak and damage floor. Roof leaks / daylighting through louvers / vents.

Confirmed asbestos in exterior window glazing/caulking, not abated with assumed asbestos in built-up roof.

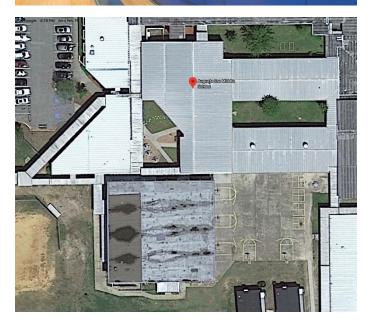
The existing roof is 37 years old with no current warranty. The dark spots in image to the left illustrates standing water. Building 10 is in dire need of a new roof and it is not serviceable in any way. Roof leaks are ongoing and continue to damage the wood gym floor.

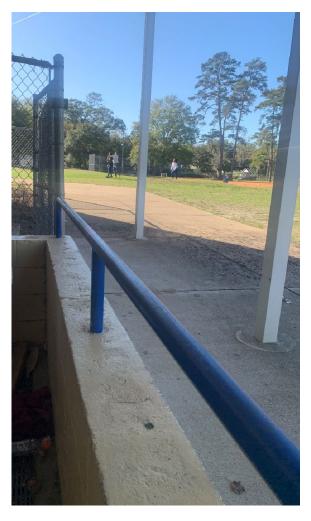
No covered ADA walkway to access the locker rooms.

No covered accessible route from parent or bus drop-off.
